# Assessment of Pavement Condition Index of The Federal Polytechnic Ado-Ekiti Campus Roads, Ekiti State, Nigeria

<sup>1</sup>Akinwamide Oluwayinka G\*, <sup>2</sup>Akinwamide Joshua T., <sup>3</sup>Emmanuel Adesina A.

The Federal Polytechnic Ado-Ekiti

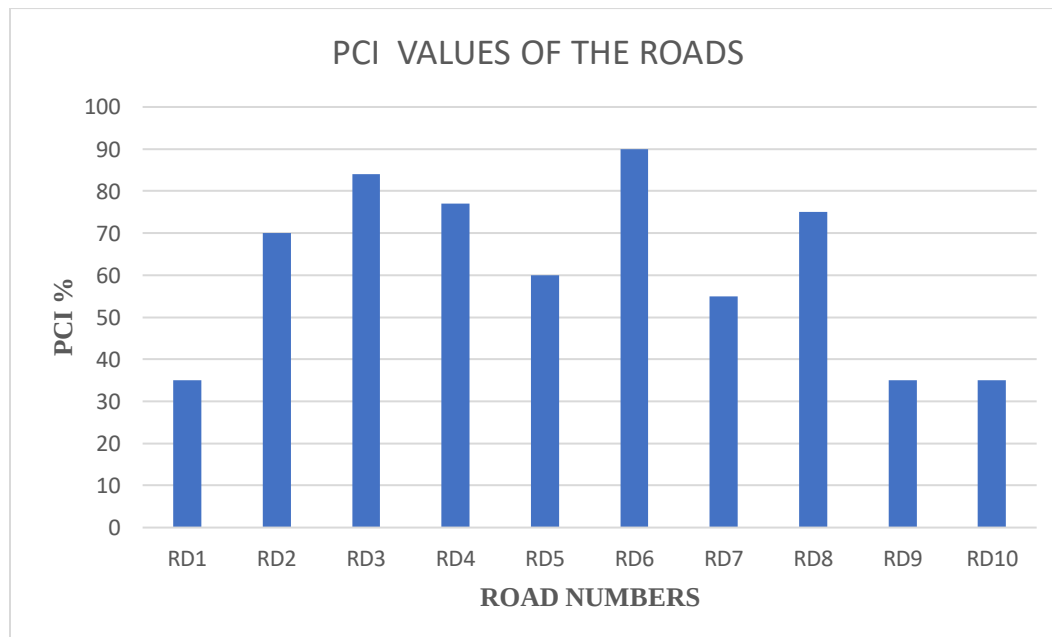
Figure 5: Bar chart showing the PCI values of roads studied

The summary result of assessment of pavement condition performance for all the roads studied is presented in Table 3. Detail of how the parameters were determined was presented for better understanding were as shown in the appendix. The bar chart of the PCI value of all the roads was presented in Figure 5. From the results, it was observed that cracking is more prevalent in most of the roads ranging from block cracking, alligator cracking, longitudinal cracking, transverse and edge cracking. For road 1, block cracking is the major defect on the road taking a total percentage of 49.23%. This may be as a result of poor surface camber and drainage system as noticed on the road section. Delamination defect took 0.32%, pothole was 0.22%, alligator cracking was 8.92%, while joint reflective cracking was 41.3%. For road 2, joint reflection and longitudinal cracking are the major distresses noticed on the road which are about 68.42% and 24.21% respectively. These distresses noticed can be associated with thermal, fatigue and construction problem. For road 3, edge cracking and block cracking are more predominant taking 82.7% and 16.37% respectively. This can be resulted from environmental effect such as temperature, rainfall and poor construction in form of inadequate compaction of the road surface during construction. For road 4, block cracking both low and medium severity are noticed on the road, taking 87.36% of the total road distress. This type of distress that was predominant on this road can be as a result of high water level in the area. The road passes through a major water logged area of the campus. For road 5, edge cracking and block cracking were predominant on the road taking a total of 52.03% and 45.72% of the road area respectively. Longitudinal cracking was also noticed on the road. The possible cause of cracking on this road can be temperature fluctuation, insufficient thickness or material strength, construction issues, settlement of the underlying layers and weak or unstable subgrade causing pavement distress. For road 6, the only distress observed is edge cracking which may be resulted from construction problem or underlying problems. Road 7 and 8 are dual carriageways, the most significant distress observed there were joint reflective cracking and raveling. The possible cause of raveling may be aging and poor material. For road 9 and 10 which are also dual carriageways, raveling is 100% prevalent on the road. The surfaces are rough and possess high surface texture. This may be as a result of weak aggregate.
