Integrating Stepwells into Urban Water Management Systems: A Case Study of Ahmedabad Stepwells

Dr. Meenakshi Pawar¹, Nevy Malhan²

ABSTRACT

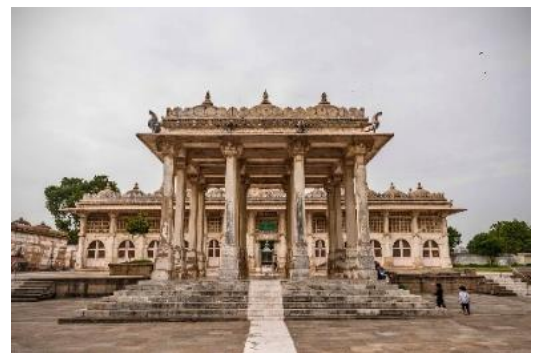
Figure 11. Sarkhej Roza–Makarba complex and associated water tanks. Image credit: Gujarat Tourism

Historically, the Sarkhej reservoir and associated waterworks – comprising lakes, tanks, sluices, and channels – were part of a carefully planned hydrological network rather than mere ornamental structures. The main reservoir spanned over 17 acres and was fed by the interconnected Makarba Lake, a natural water body, through three sluice gates forming a cascade. The combined catchment area of 1.74 km² ensured that overflow from Makarba Lake sustained Sarkhej Lake year-round, creating a perennial waterbody that moderated the microclimate of the adjacent complex and supported surrounding communities (Mishra et al., 2019).

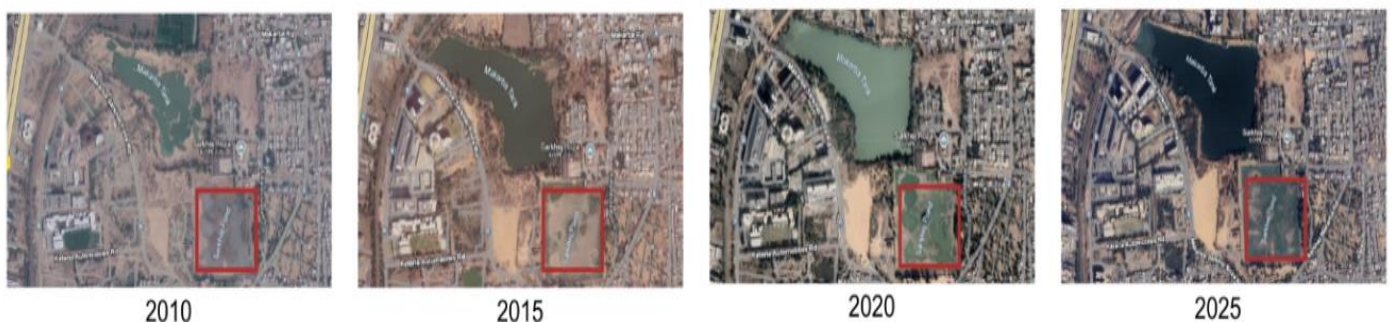
Figure 12. Hydrological relationship between Sarkhej Roza tanks and the surrounding catchment. Image credit: Google Earth

Figures 4 and 5 depict the location, seasonal variation, and historical mapping of Sarkhej Lake and its surroundings, illustrating both its original hydrological design and the impact of urban encroachment. Rapid urbanisation, particularly after 2000, has led to the encroachment of roughly 50 per cent of the catchment area, significantly reducing natural inflows and disrupting hydrological connectivity (Mishra et al., 2019). The lake now functions primarily as a seasonal waterbody, relying almost entirely on monsoonal inputs, highlighting the urgent need for restoration.
