# Investigation and Mitigation of Harmonic Distortion and Parallel Resonance in an Industrial Power System Using ETAP

Rajvi Y. Matiyeda, Prof. Ajay M. Patel, Patel Harshkumar R.

Department of Electrical Engineering, Birla Vishvakarma Mahavidyalaya Engineering College, India

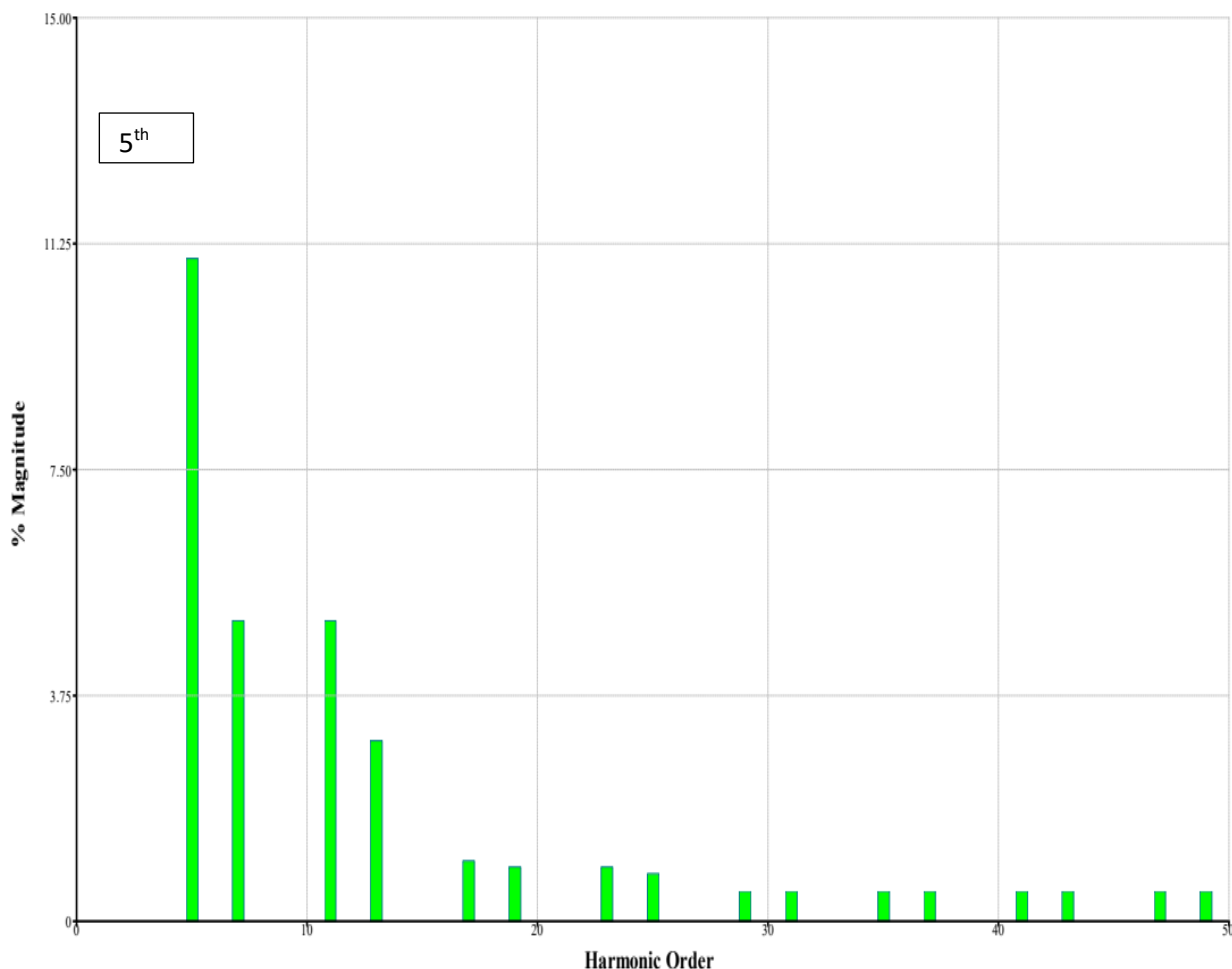
Figure 1: Harmonics spectrum

Figure 1 The harmonic spectrum indicates dominance of the 5th harmonic component, which is typical in industrial systems employing 6-pulse rectifier based variable frequency drives. Characteristic harmonics generated by such converters follow the order  $h = 6k \pm 1$ , making the 5th harmonic the lowest and most significant component.

Additionally, the negative sequence nature of the 5th harmonic contributes to increased motor heating and losses. The presence of capacitor banks in the network further increases the possibility of parallel resonance near the 5th harmonic frequency, resulting in amplification of distortion at Load Centre-01.

A single-tuned passive filter tuned to the 5th harmonic (250 Hz) was selected due to the clear dominance of the 5th harmonic component and its cost-effective implementation compared to active filtering solutions. The filter provides a low-impedance path for harmonic currents while simultaneously improving reactive power compensation at the bus. Passive filtering was preferred over active filtering due to lower installation cost, reduced maintenance requirements, and predictable harmonic spectrum in cement plant drives.

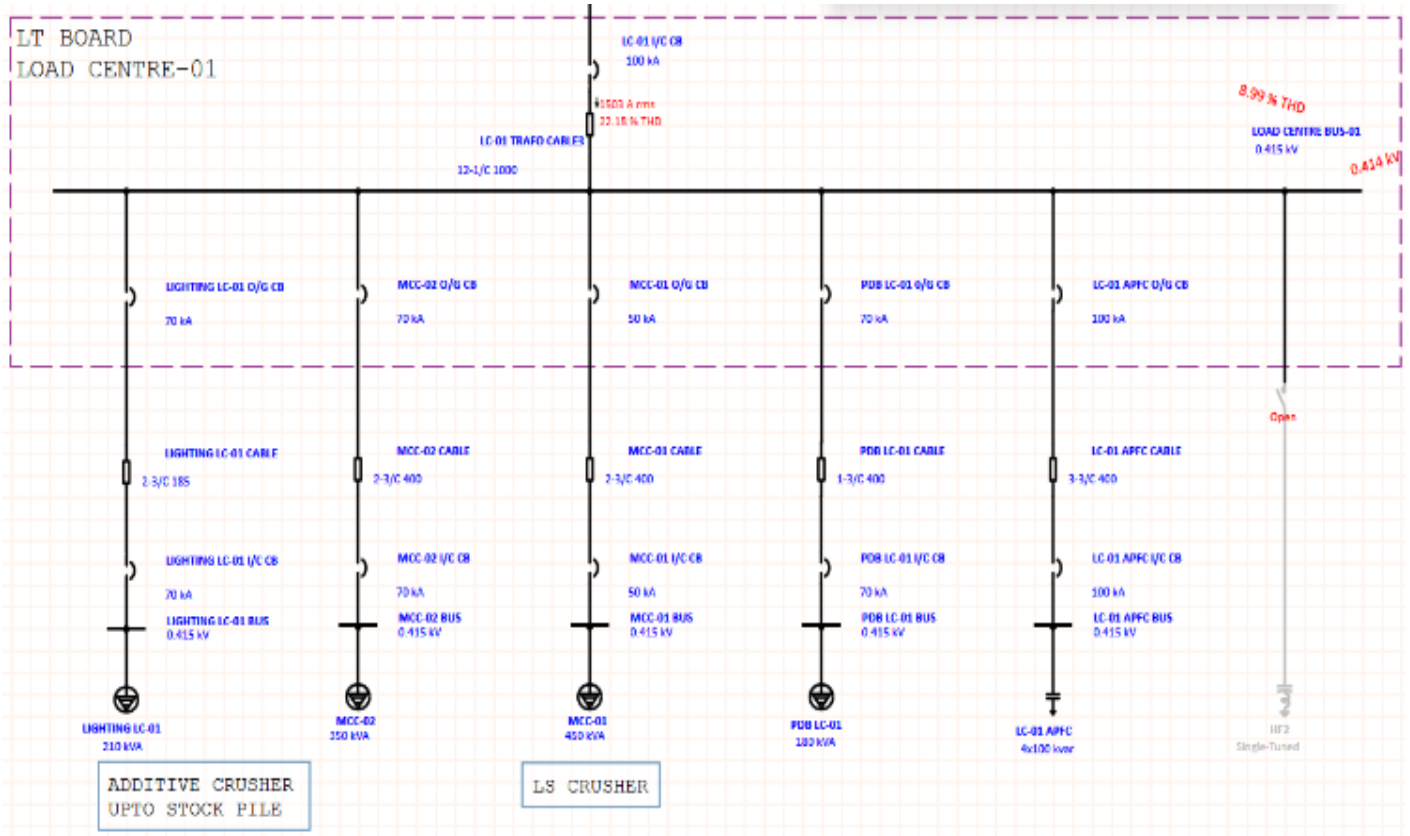
Figure 3: THD level at Load Centre-01 bus before mitigation

After installing the filter, the current THD at the bus reduced from 22.18% to 6.83%, bringing the harmonic distortion within acceptable IEEE 519 limits. The post-mitigation results confirm the effectiveness of the filter, with THD reduced below IEEE 519 recommended limits. Additionally, no adverse resonance amplification was observed in the impedance scan, validating the stability of the proposed mitigation strategy. This solution has improved power quality, reduced the thermal stress on cables and transformers, and ensured regulatory compliance.

Figure 4: THD level at Load Centre-01 bus after mitigation

| Bus Location | THD-I Before (%) | THD-I After (%) | IEEE 519 Limit | Compliance |
| Load Centre-01 | 22.18 | 6.83 | 8% | Achieved |

Table 2: THD level at Load Centre 01 bus

Importantly, the addition of the filter did not introduce any new parallel resonance issues. This is because the system's parallel resonance frequency was located near the 3rd harmonic (~150 Hz), and 3rd harmonic components are negligible in the system due to the absence of their sources.

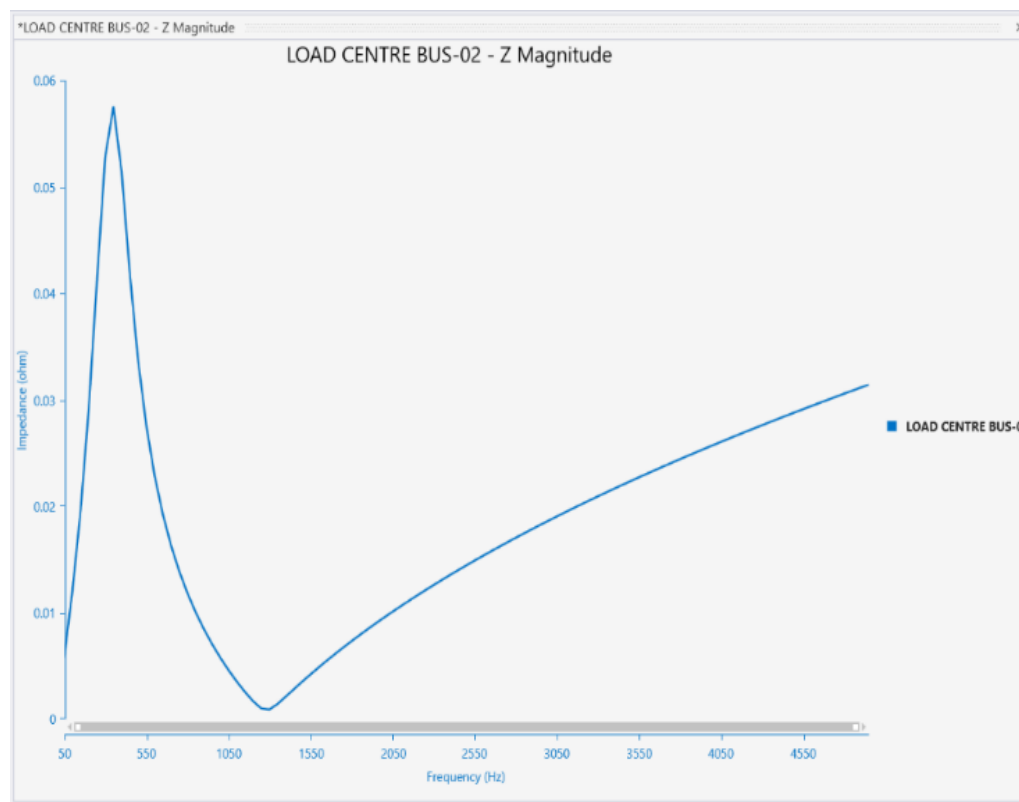
**Figure 5: Parallel Resonance condition**

The frequency scan results indicated a resonance peak near the 7th harmonic frequency ( $\approx 350$  Hz), where the system impedance increased to approximately  $0.057 \, \Omega$ . The Thevenin impedance at the bus was calculated as  $0.0053 \, \Omega$ , resulting in a resonance amplification factor exceeding 10. According to industrial harmonic mitigation practices, such impedance magnification indicates a high risk of harmonic voltage amplification even when THD levels remain within IEEE 519 limits.

The resonance condition was primarily caused by the interaction between the 600 kVAR capacitor bank and the upstream system inductance. Although measured THD values were acceptable, sustained operation under this condition could lead to capacitor overstressing, insulation degradation, and possible protection maloperation. Therefore, frequency scan analysis is essential in addition to THD assessment when capacitor banks are present in industrial distribution systems.

**Parallel Resonance at Load Centre-02 Bus:** During the harmonic analysis at Load Centre-02 bus, a parallel resonance condition was detected due to the connection of a 600 kVAR capacitor bank. The system's Thevenin impedance at the bus was calculated using the following formula:

To mitigate this issue, a detuned reactor was installed in series with the capacitor bank. The original capacitive reactance was calculated as  $X_c = 0.287 \, \Omega$ . A 7% detuning factor was selected, resulting in an inductive reactance

of  $X_L = 0.0179 \Omega$ . The addition of this series inductance shifted the resonance frequency from the 7th harmonic to approximately the 3rd harmonic ( $\approx 150$  Hz), where harmonic content in the system is negligible.
