# Industrial Practices in Repair, Maintenance, and Performance Evaluation of three-Phase Induction Motors: A Practical Case Study

## ABSTRACT

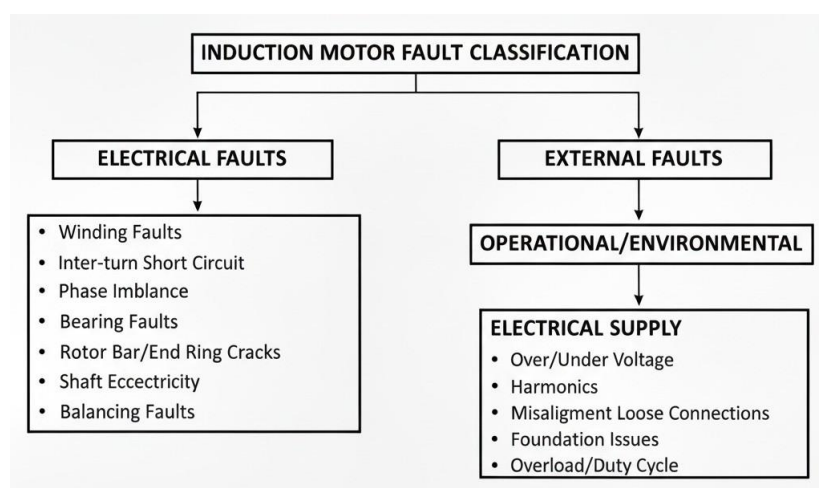
**Figure 3. Hierarchical classification of induction motor faults, showing the relationship between major fault categories and their sub-types.**

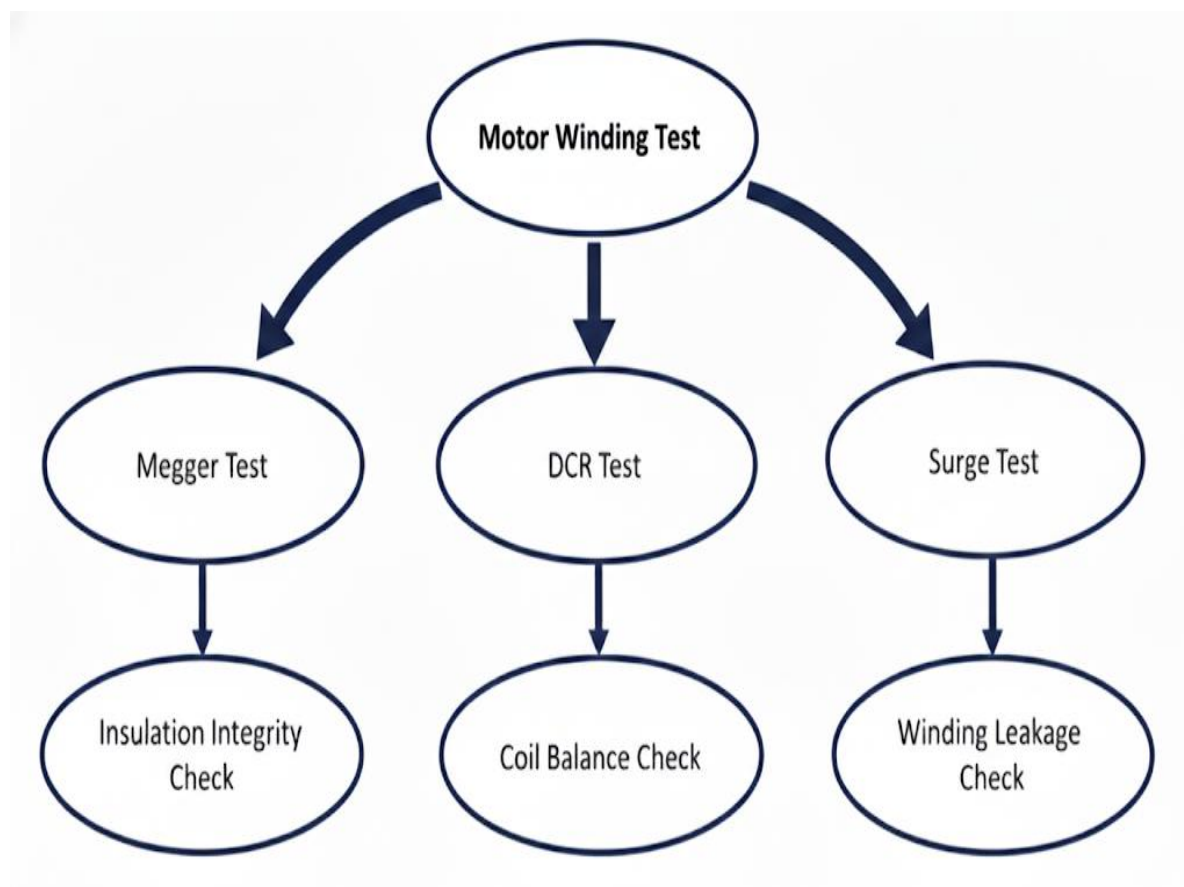
**Figure 4. Key stages of the stator winding verification process.**

D. Winding Section — performs stator winding inspection (DCR, Megger, surge) and determines the winding layout from the relationship between speed, poles, slots, and coil pitch.

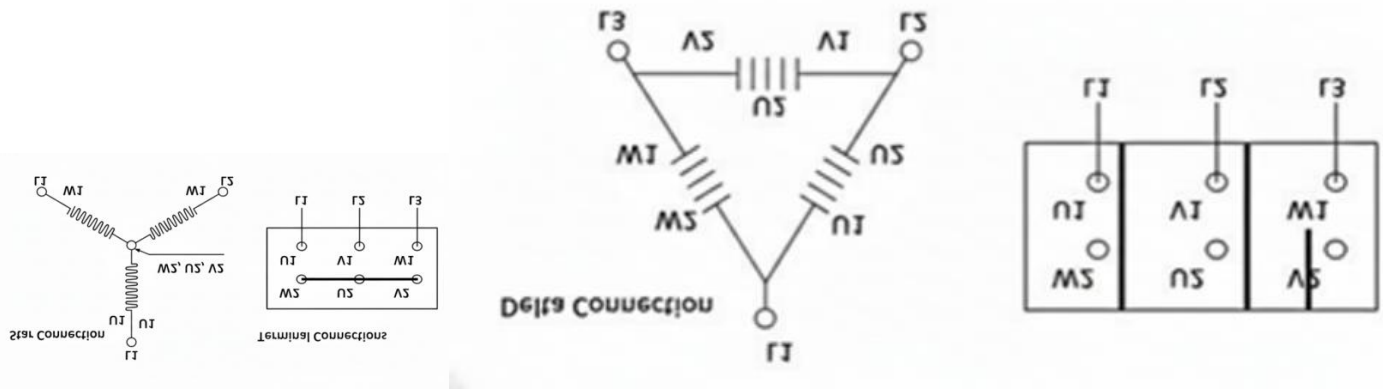
**Figure 5. Internal configuration of the motor terminal box, showing delta (left) and star (right) connection links.**

The motor is received at the service and assembly section, the thermal box is removed to expose the terminals, and the existing connection (star or delta) is identified from the arrangement of link plates before any wire is disconnected.

- Delta connection: link plates placed vertically, each connecting a start terminal of one phase to the end terminal of another (U1–U2, V1–V2, W1–W2), forming a closed-loop circuit suited to high-torque applications.
- Star connection: link plates placed horizontally, joining the three end terminals (U2, V2, W2) at a common neutral point while the start terminals (U1, V1, W1) receive the supply; this configuration reduces starting current.

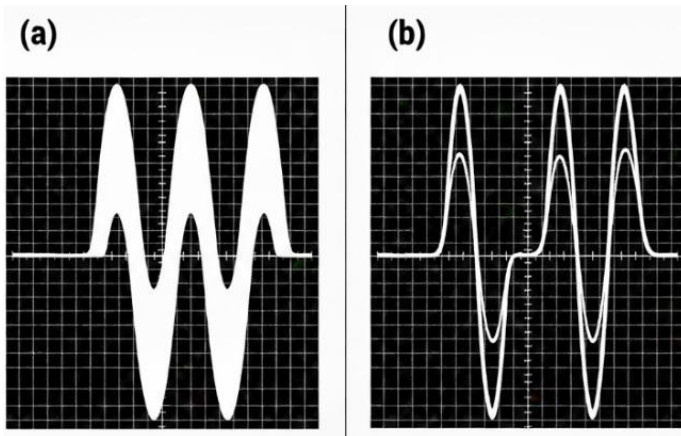
| Condition | Observation | Diagnosis |
|---|---|---|
| Pre-repair (faulty) | Visible separation between Phase U and Phase V waveforms | Turn-to-turn short (carbonised inter-conductor insulation) |

**Figure 12. Final surge-test waveform comparison. (a) Healthy condition — superimposed waveforms; (b) faulty condition — visible waveform separation indicating a turn-to-turn short.**

| Condition | Observation | Diagnosis |
|---|---|---|
| Post-repair (healthy) | All three waveforms (U, V, W) superimposed | Balanced inductance/resistance; insulation withstands high-voltage transients |

A high-voltage pulse was applied to each phase (HV lead on U1/V1/W1, ground lead on the motor core) to generate a decaying oscillation waveform for comparison across phases.

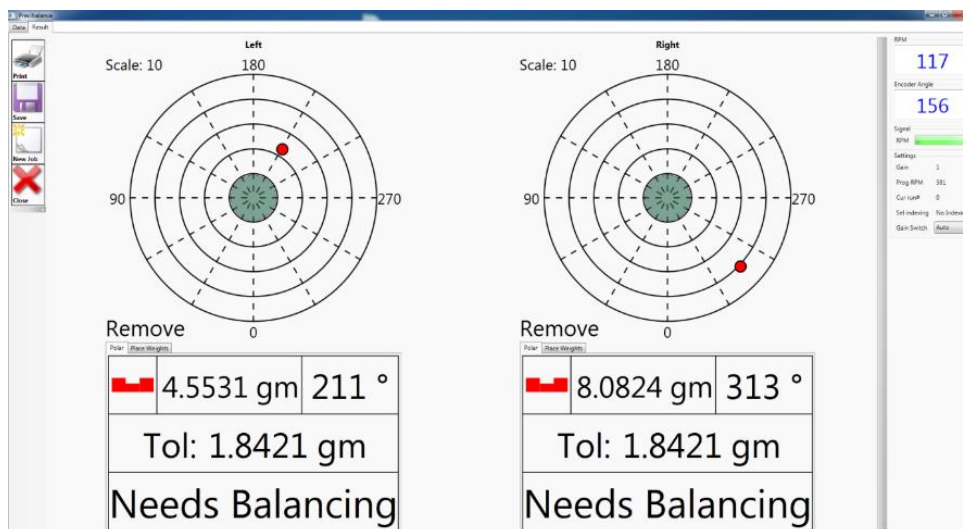
**Figure 13. Graphical interface of the digital balancing analyser, showing unbalance magnitude, angular position, and tolerance limits for the left and right correction planes.**

Balancing was carried out on a Precibalance machine, calibrated against a master rotor before use. Both static (fan-only, single-plane) and dynamic (full rotor, two-plane) balancing were performed, with correction weights calculated by the ABC method (A: distance from first pulley to rotor end; B: full rotor length; C: distance from rotor end to second pulley) and applied until residual unbalance fell below the workshop's 9 g threshold (the "Single-Digit Rule"), consistent with an ISO 21940-11 balance-quality grade such as G2.5 or G1.

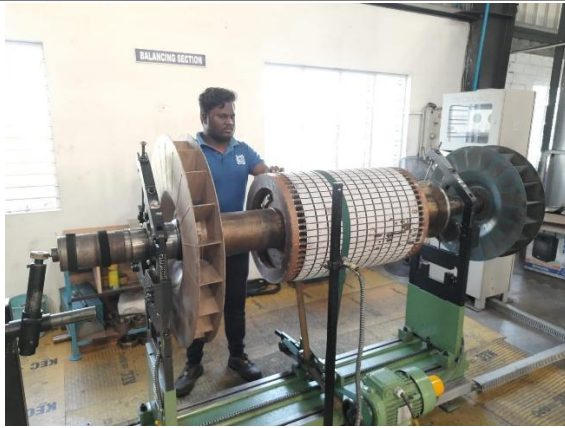
**Figure 14. Dynamic balancing of a large industrial rotor assembly on a horizontal balancing machine.**

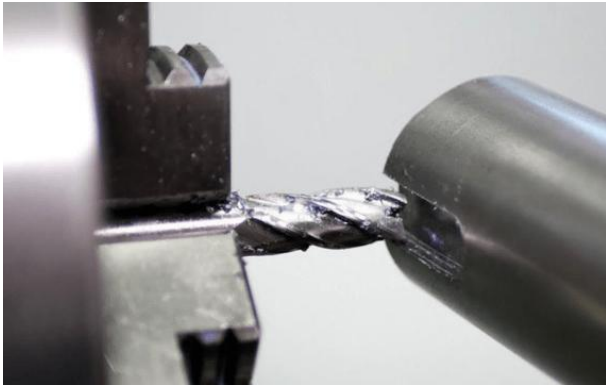
**Figure 17. Lathe machining of the motor shaft and milling of a new keyway.**

Shaft and housing reconditioning followed standard workshop practice: sleeve fitting for undersized bearing journals (shaft turned down, sleeve shrink-fitted or pressed, then machined to OEM diameter); soft-cut correction for minor eccentricity; and keyway repair by weld-filling the worn keyway and milling a new slot at a 90° or

180° offset. Welding practice used arc welding for heavy structural repairs and gas/flame welding for thinner sections, followed by controlled cooling, grinding, and inspection for porosity before final machining.

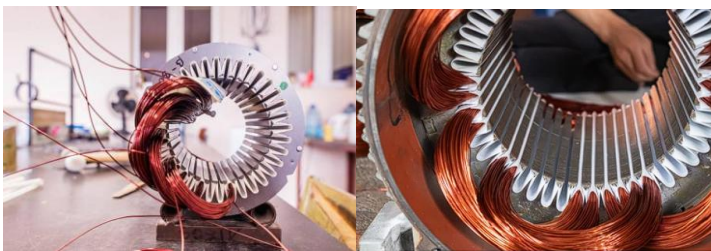
**Figure 18. Winding layout comparison — double-mesh (double-layer) winding (left) and single-mesh (single-layer) winding (right).**

Coil pitch was calculated as the ratio of total stator slots to total poles (e.g., 36 slots / 4 poles = 9 slots pitch, coil spanning slot 1 to slot 10). Synchronous speed at 50 Hz follows directly from pole count (2-pole: 3000 RPM; 4-pole: 1500 RPM; 6-pole: 1000 RPM). A long (full) pitch maximises flux and torque for a given pole configuration; a short (fractional) pitch trades some speed/force for reduced copper use, suppressed harmonics, and improved cooling. The rewound motor used an Opposite Type connection (phase coils in alternating R–Y–B–R–Y–B sequence) rather than a standard Chain Type connection, on the basis that the interleaved layout gives a more even magnetic-field distribution and lower vibration for this class of motor.
