# Physicochemical and Bacteriological Assessment of Water Quality in Kole Wetlands of Elthuruth, Kerala, India

Bolie Therattil<sup>1</sup>

<sup>1</sup>Associate Professor, Department of Chemistry, St. Aloysius College, Elthuruth, Thrissur – 680 121, Kerala, India (Affiliated to University of Calicut)

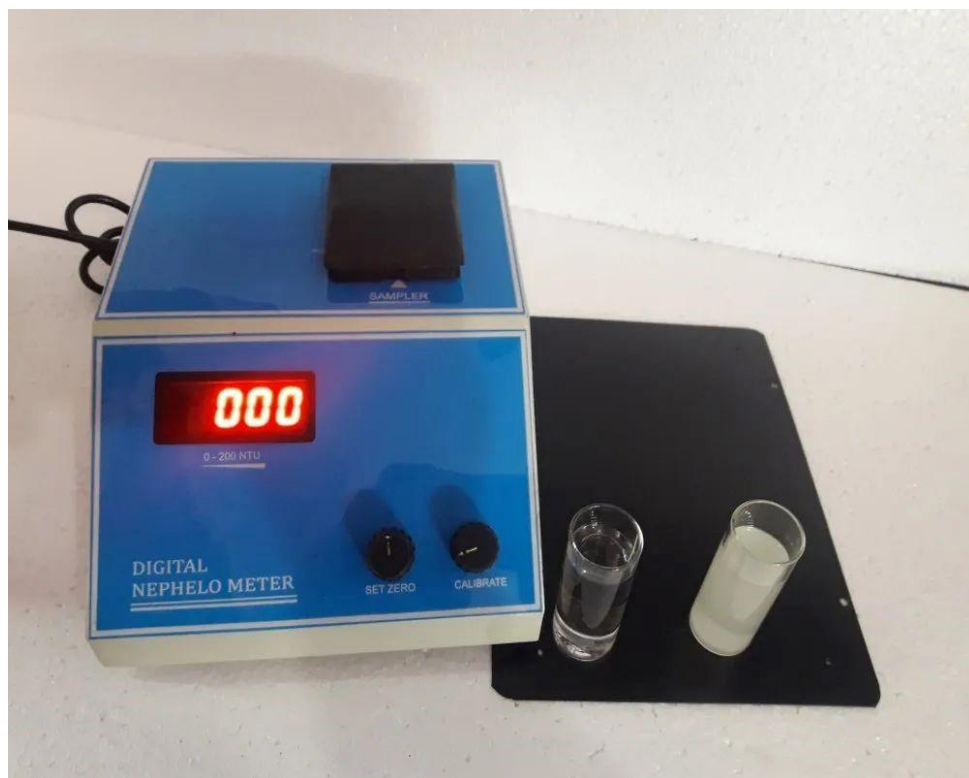
Figure 1: Digital Nephelometer (0-200 NTU range) — used for Turbidity and Sulphate measurements

Turbidity was measured using a digital nephelometer calibrated with formazin turbidity standards. Water samples were placed in clean cuvettes free from scratches or fingerprints, and turbidity was recorded in Nephelometric Turbidity Units (NTU).

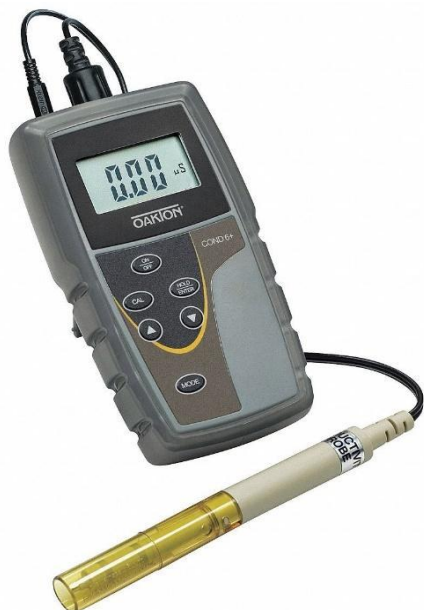
Figure 2: Conductivity Meter (Oakton COND 6+) — used for Electrical Conductivity measurement

The conductivity meter was calibrated using standard 0.01N KCl solution at 25°C (EC = 1411.8  $\mu\text{S}/\text{cm}$ ). Water samples were directly measured with the probe immersed in the sample, and readings were recorded in  $\mu\text{S}/\text{cm}$  with automatic temperature compensation.

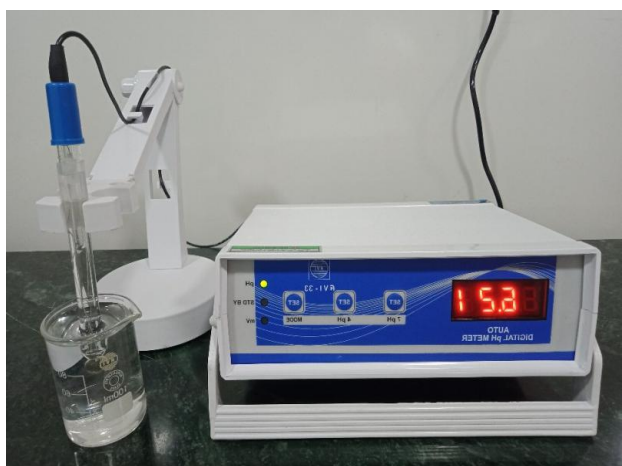
Figure 3: Auto Digital pH Meter (RVI-33) — used for pH measurement

The pH meter was warmed up for 10 minutes, then calibrated with standard buffer solutions of pH 2, 4, 7, and 9.2. About 70 mL of the water sample was transferred into a 100 mL beaker and the electrodes were immersed to read the pH value directly.

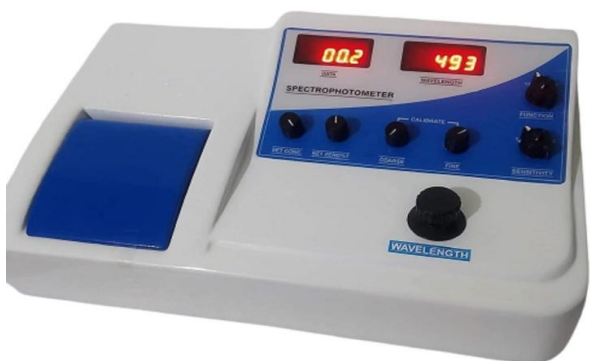
Figure 4: Spectrophotometer — used for Iron, Fluoride, and Nitrate analysis

A spectrophotometer was used for colorimetric analysis. Standard calibration curves were prepared for each analyte: (a) Fluoride — using SPADNS reagent at 570 nm; (b) Iron — using phenanthroline reagent at 510 nm; and (c) Nitrate — using brucine sulfate reagent at 410 nm. Sample concentrations were determined by comparing absorbance values against the calibration curves.
