# Environmental Impact Assessment of Peruru Banda Hill Before and after the Construction of The Vakulamatha Temple at Tirupati, Andhra Pradesh, India

## ABSTRACT

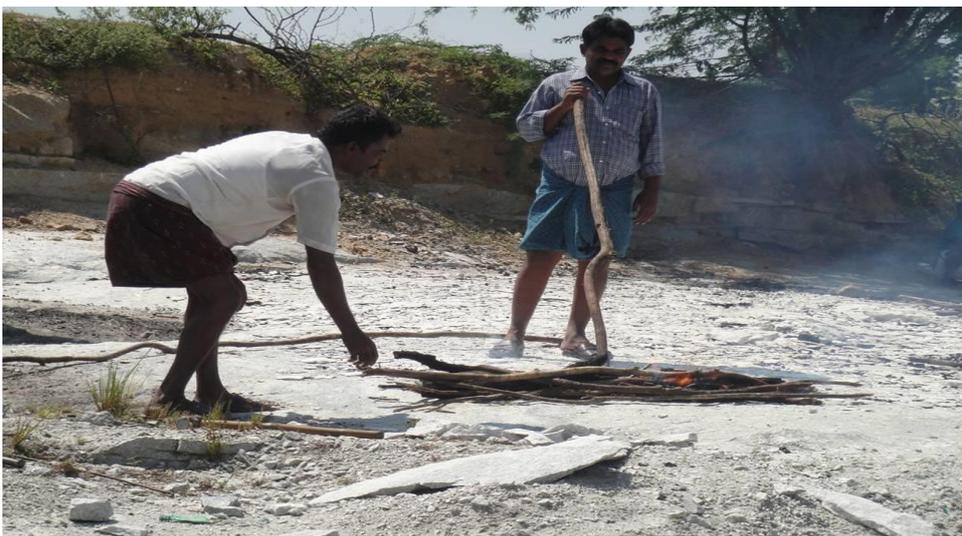
**Fig. 2:** Firesetting on granite of Peruru Banda

Quarrying of Peruru granite has been carried out since around 10<sup>th</sup> century with local artisans developing ingenious methods of mining that produce little sound and little air pollution. The first one involves burning firewood at surface (Fig. 2) and the second one uses a mini-explosive placed in a single narrow hole to a small depth (Fig. 3). By this, various dimension stones used in civil engineering works, road metal, fence posts, household utilities and kitchen tools could be produced (Figs. 4 and 5). The works of Mahalingam (1970) and Craddock (1996) highlight the exceptional skills exhibited by Peruru artisans.

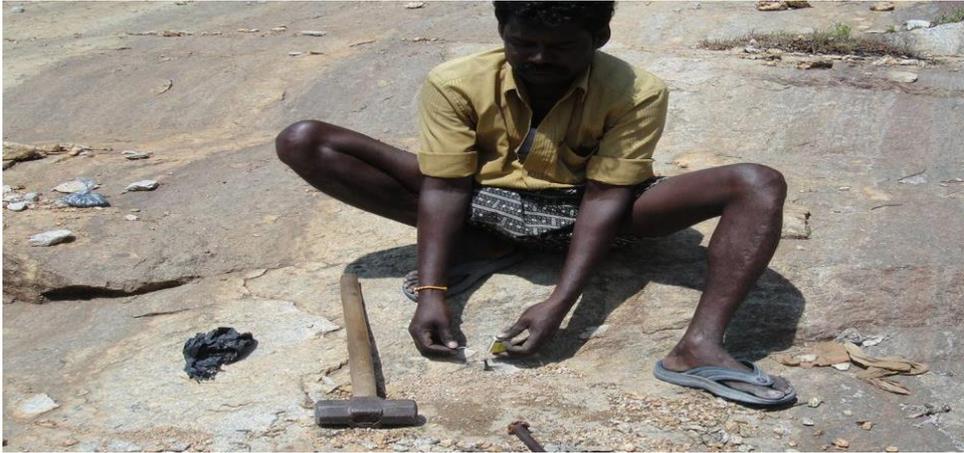
**Fig. 3:** Driving a hole into the rock with hammer for mini-blasting.

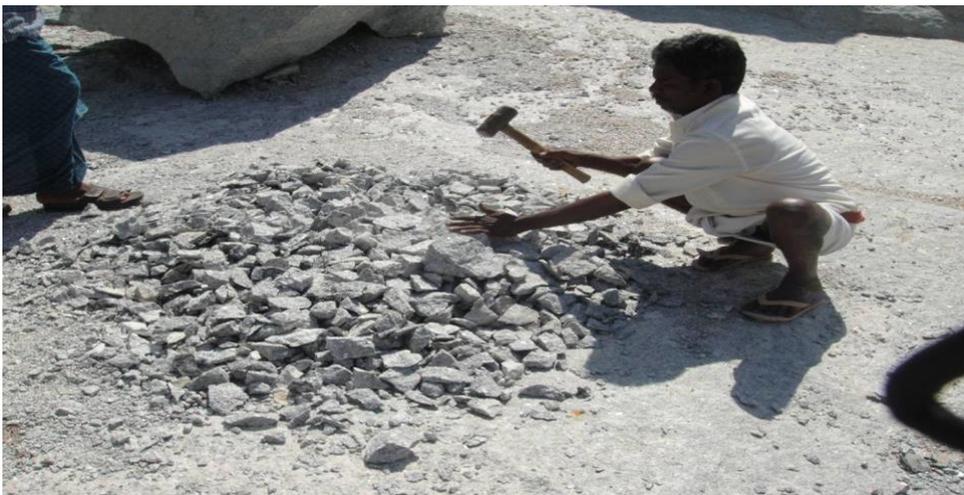
**Fig. 4:** Making road metal using a hammer

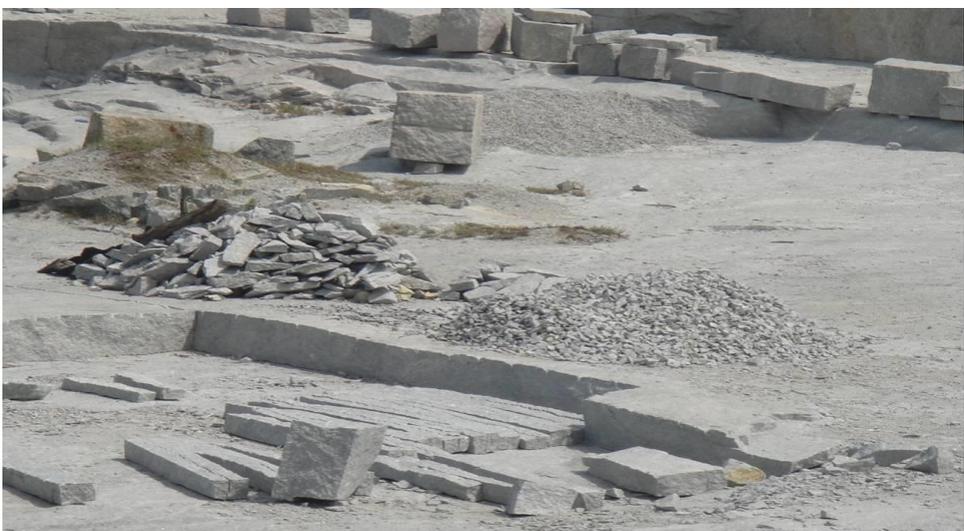
**Fig. 5:** Obtaining dimension stones of various sizes

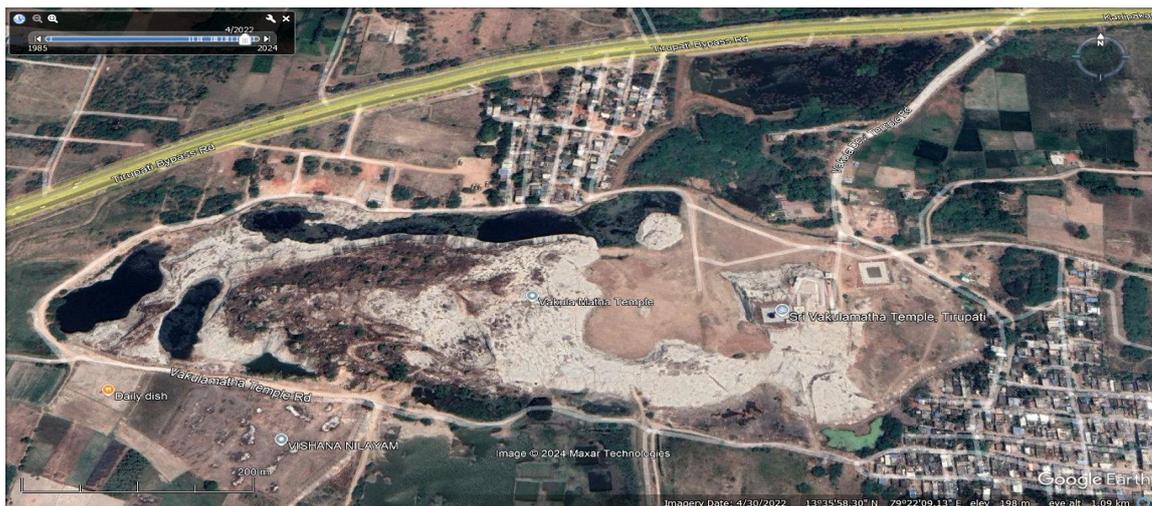
**Fig. 12:** A Google Earth Pro (GEP) image of Peruru Banda Hill captured as on 30<sup>th</sup> April 2022

In order to understand the environmental impact of the Vakulamatha temple on the western portion of the Peruru Banda Hill, two high-resolution Google Earth satellite imageries have been generated using the Google Earth Pro software made available in the public domain on free basis. Of these, Figure 12 refers to the imagery dated 30<sup>th</sup> April 2022 corresponding to the date of construction of the temple, while Figure 13 refers to the imagery dated 17<sup>th</sup> April 2025 corresponding to the environmental conditions as on now.

From the observation that there is near doubling of water-logged area in the western portion of the Peruru Banda, it can be concluded there has been a change of environment from bad to worse. This change has been attributed to the entry of floodwaters from the Peruru Tank abutting the Peruru Banda Hill in the north entering into the low-lying areas.

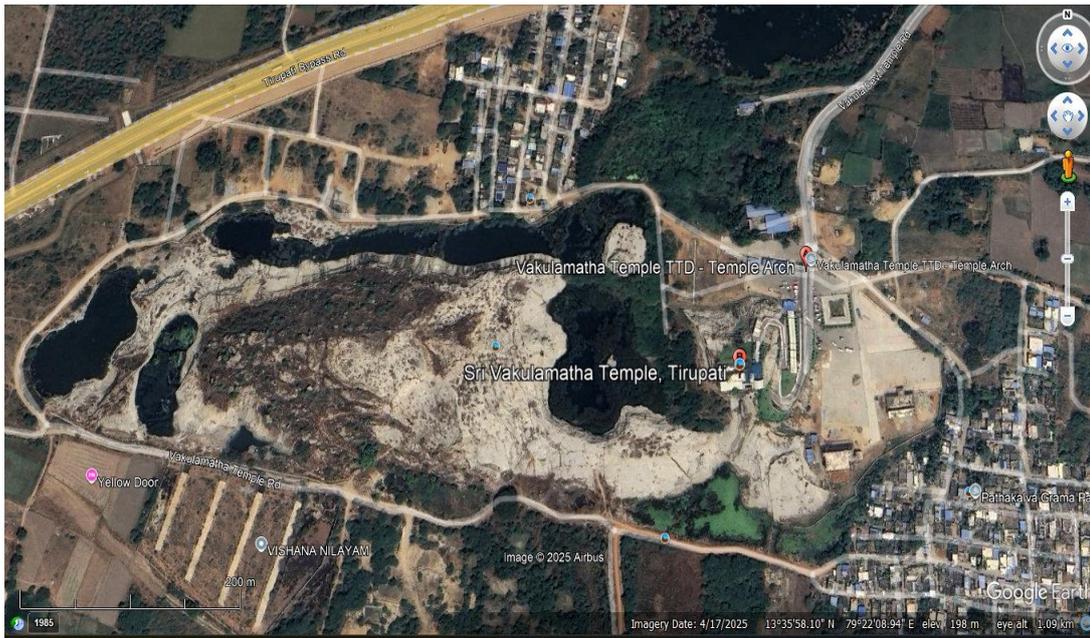
**Fig. 13:** A Google Earth Pro (GEP) image of Peruru Banda Hill captured as on 17<sup>th</sup> April 2025.

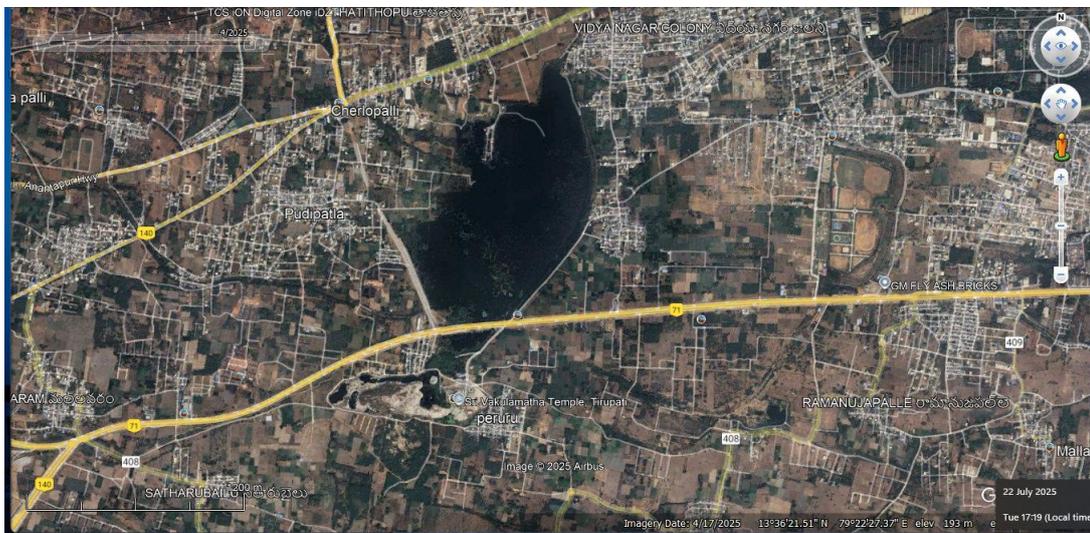
**Fig 4:** A Google Earth Pro (GEP) image of Peruru Banda Hill and Peruru Tank captured as on 17<sup>th</sup> April 2025.

Fig. 15 is the Google Earth Pro image showing both Peruru Banda Hill and Peruru Tank abutting it in the north. It is evident from this Figure that all the low-lying areas of the Peruru Banda Hill are fed by the surface water in the Peruru Tank.

The works of Jagadiswara Rao et al (1978), Srinivasulu (2006) and Venkateswarlu (2021) in the Upper Swarnamukhi river basin indicate that the Peruru Tank is so heavily silted that any small rain fills the Tank to the brim with excess water submerging the low-lying areas in the Peruru Banda Hill and other low-lying areas in Tirupati. The only way this problem could be tackled effectively is through dredging of sediments accumulated in the Peruru Tank and use the dredged material to fill up the low-lying areas of the Peruru Banda Hill into a
