# Leachate Characterization, Pollution Load Assessment, and Waste Management Infrastructure Policy for an Unregulated Open Dumpsite in a Tropical Peri-Urban Environment: Evidence from Benin City, Nigeria

Osayande, A. D.<sup>1</sup>; Okojie, M.E.<sup>2</sup> and Offiah, E.N.<sup>3</sup>

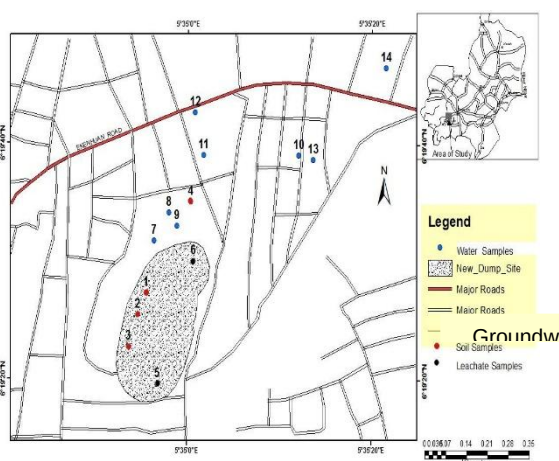
FIG. 1: MAP OF AREA OF STUDY SHOWING THE SAMPLED LOCATIONS

The Upper Ekehuan (Asoro) dumpsite is located at 6°19'20"-6°19'40"N Latitude and 5°35'0"-5°35'20"E Longitude in Ovia North-East LGA of Benin City, Edo State Nigeria. The dumpsite is situated in a basin-shaped depression with a gentle slope to the terrain such that surface runoff from the adjacent roads and residential areas is channeled into the waste deposit site. Two leachate seepage zones were identified: L1 at the central depression and L2 approximately 20 meters to the north of L1. The dumpsite accepts mixed municipal solid waste with no provision for source segregation. The average annual temperature is 27-32°C with 1,800-2,200 mm average annual rainfall, providing a highly active decomposition environment with high leachate production rates year-round.
